Expanded Site Inspection Report

**Pedricktown Support Facility
Salem County, New Jersey**

December 21, 1993

***Versar* Inc.**

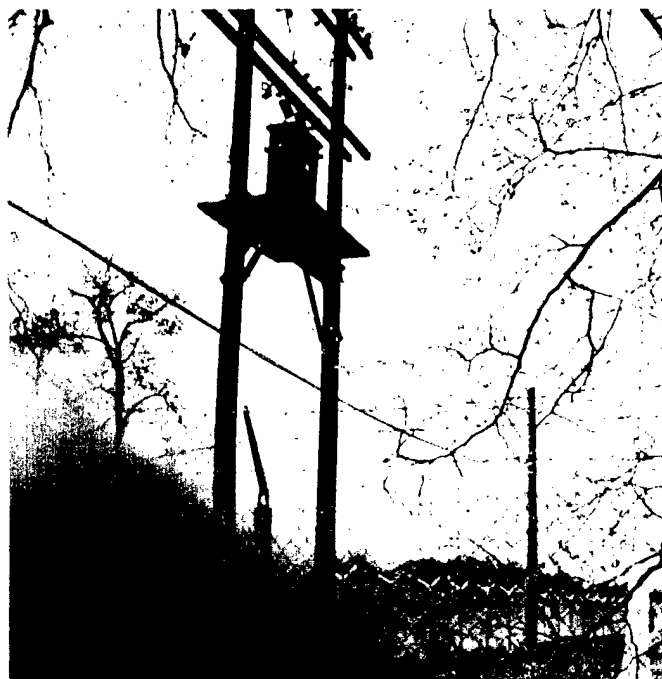
PHOTOGRAPH 31

<u>Photograph Number</u>	<u>View Direction</u>	<u>Description</u>
30	Southeast	Ground-mounted transformers southwest of Building 495.
31	West	Modified pole-mounted transformer west of Building 229.
32	North	Pole-mounted transformers north of Building 273.
33	Northeast	Pole-mounted transformers south of Building 351.
34	Northwest	Pole-mounted transformers northwest of Building 380.
35	Northeast	Pole-mounted transformers southwest of Building 464.
36	Southeast	Pole-mounted transformers southeast of Building 269.
37	East	Pole-mounted transformer north of Building 184.
38	Southeast	Pole-mounted transformer southwest of Building 474.
39	Southeast	Pole-mounted transformer southwest of Building 434.
40	North	Pole-mounted transformer west of Building 380.
41	East	Pole-mounted transformer northwest of Building 197.
42	North	Pole-mounted transformer north of Building 273.
43	South	Pole-mounted transformer northwest of Building 286.

vicinities, the transformers should be thoroughly inspected and wipe samples taken from the surface of each suspected of leaking. If PCBs are detected in the wipe samples as well as in the corresponding soil, the transformer(s) should be replaced, and the contaminated soil remediated.

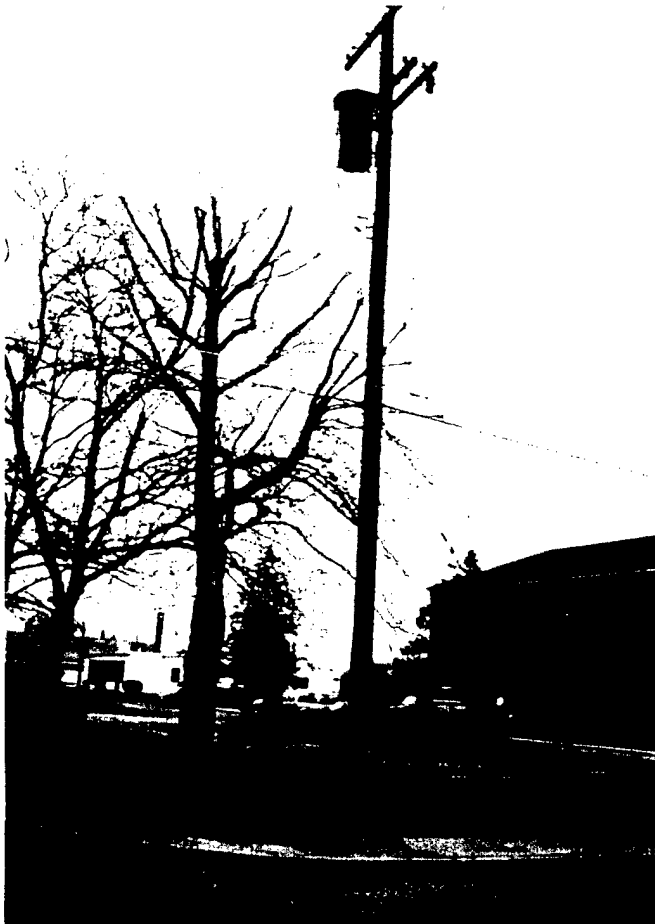
PHOTOGRAPH 46

44	West	Pole-mounted transformer west of Building 273.
45	East	Pole-mounted transformer southwest of Building 120.
46	Southeast	Pole-mounted transformer northwest of Building 190.
